СЕЛЕВЫЕ ПОТОКИ: катастрофы, риск, прогноз, защита

DEBRIS FLOWS: Disasters, Risk, Forecast, Protection

Dynamic of the 17th January 1945 debris flow in Chavín de Huantar, Ancash, Peru

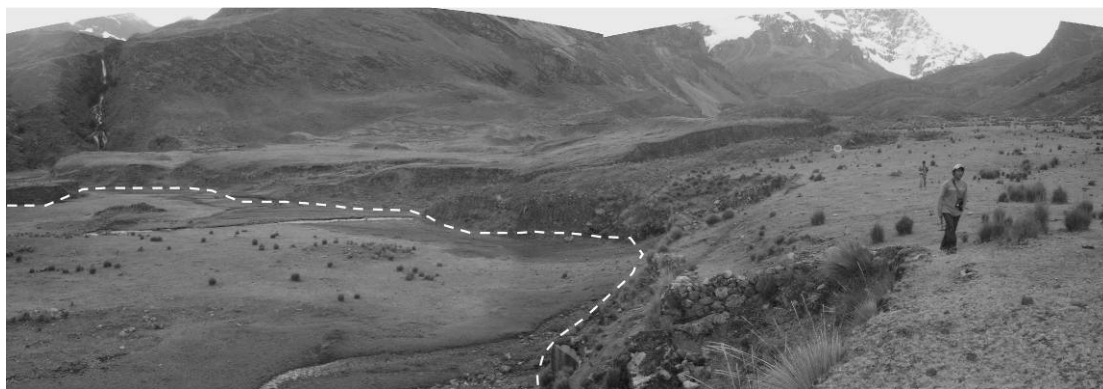
Fig. 3. Trajectory zone of the 1945 debris flow, the dashed lines show the boundaries of the deposit zone. Photo by B. Zavala, 2006.

The debris flow went down by the river bed of Alhuíña ravine (with average slope of 20°) carrying a lot of moraine and rock material. With the enlargement of the valley and the reduction of the slope ($0^\circ - 2^\circ$) the flow decelerates and deposit packsaddles with thicknesses according to the morphology of the terrain, between 0.5 – 10 m, in this zone it deposited approximately 1500000 m^3 of material (Fig. 3). When the valley become narrow and increasing the slope again (6° average) the flow gets faster and eroding the foothills of the mountains in the Huachecsa valley, that event originate several mass movements (Zavala and Valderrama, 2007).

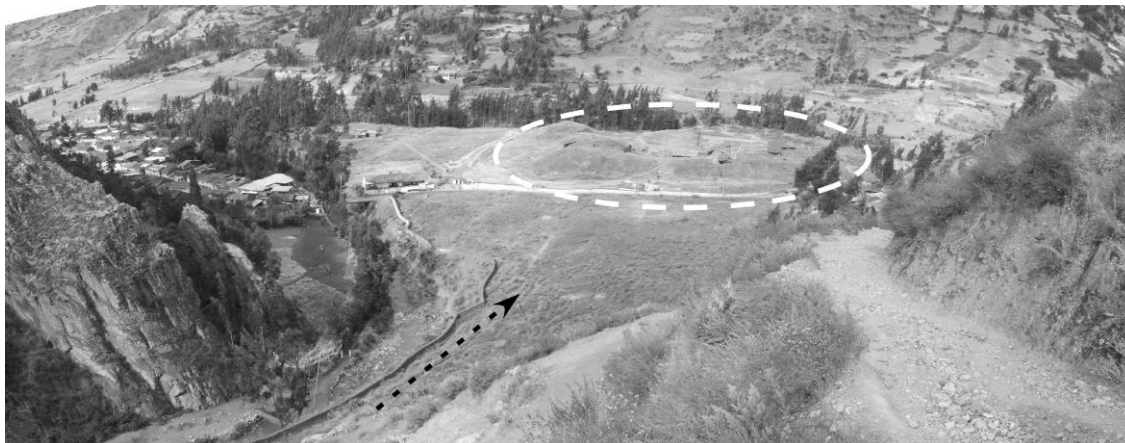
Fig. 4. Alluvial fan where Chavín de Huantar is located (in white discontinuous lines). The direction of the debris flows of 1945 shows the interrupted black arrow. The small town of Chavín is in the right corner. Photo by B. Zavala, 2006.

The flow ended up its course in an alluvial fan formed by the overlap of several ancient flows, at the Mosna River debouchments. The flow entered with an approximate height of 6m, creating a deposit of 600 m of length and a volume estimated of material of 900 000 m³ approximately (Indacochea et al., 1947) covering great part of the archeological complex of Chavín de Huantar and the small town of Chavín (Fig. 4).
