**International Conference
DEBRIS FLOWS:
DISASTERS, RISK,
FORECAST, PROTECTION
Pyatigorsk, Russia
22-29 September 2008**

**Guide
to the field trip of the International
conference
“Debris flows: Disasters, Risk, Forecast,
Protection”**

**Prielbrusye
26-28 September, 2008**

**Institute “Sevkavgiprovdhoz”
Pyatigorsk 2008**

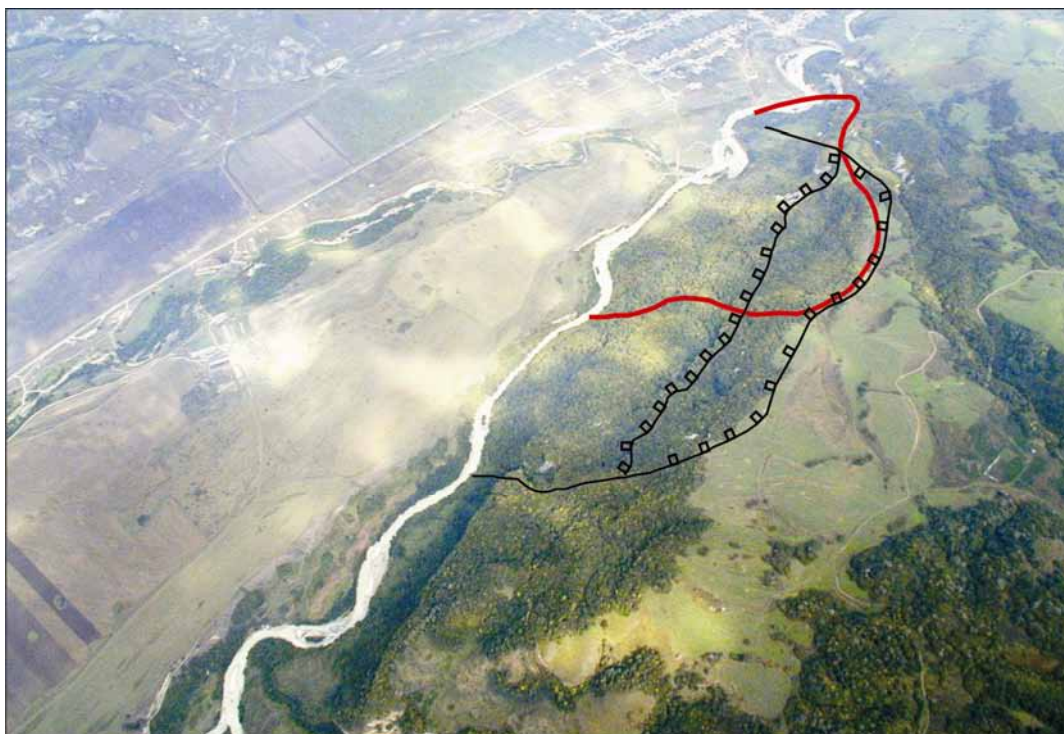
Fig. 2. The Baksan river valley in the area of the western outskirts of the Zayukovo village.

— the boundary of the ancient landslide massif

--- the ancient detachment planes

— the boundary of the shearing on the 24th May, 2005

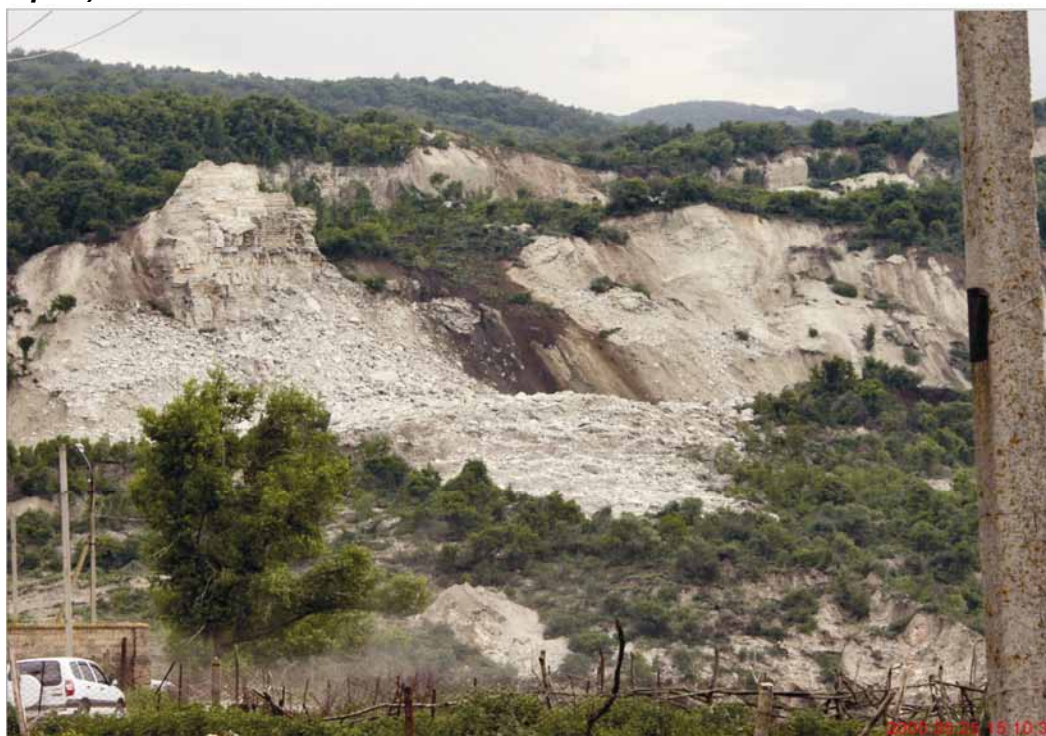
Fig. 3. The central part of the landslide with two rock detachment planes
(photo by TC GMSN "Kabbalkgeomonitoring" on the 25.05.2005, from a helicopter)

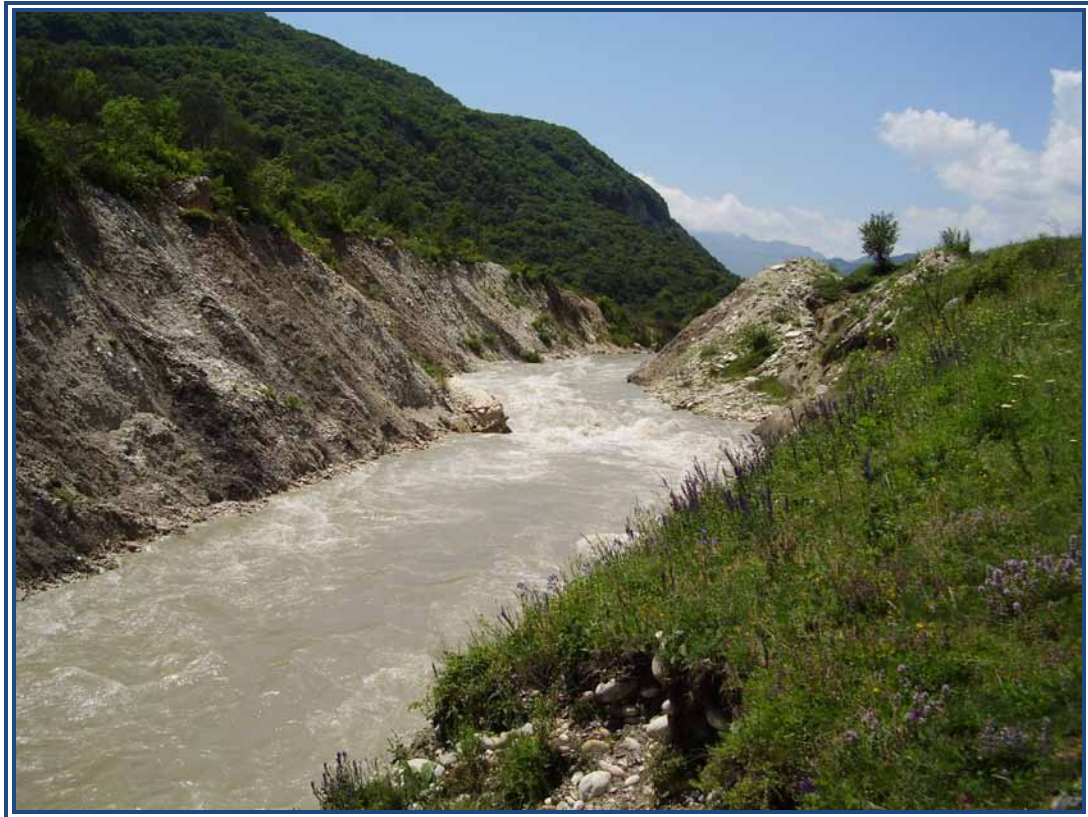
Fig. 5. 26.06.2008. The high-velocity stretch in the Baksan river channel in the area of the washed out blockage landslide dam (photo by E. Zaporozhchenko).

A rapid discharge of water masses could mean formation of a wave of a sediment water flow or water-rock flow, threatening the Zayukovo village and other settlements. However the lake discharge happened in a natural way, gradually, and within 24 hours the water level decreased by 3 m (Fig. s 5, 6 and 7).

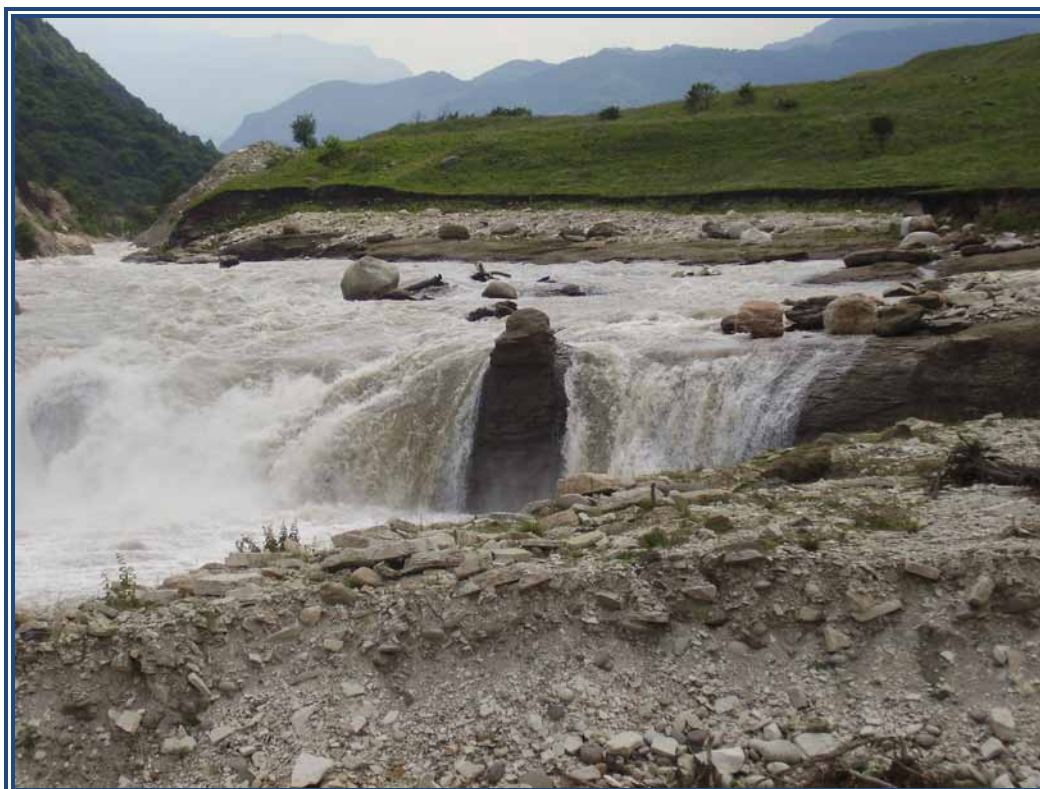
Fig. 6. 26.06.2006. In the tail-water (downstream reach) of the blockage landslide dam of the Baksan river (photo by E. Zaporozhchenko).

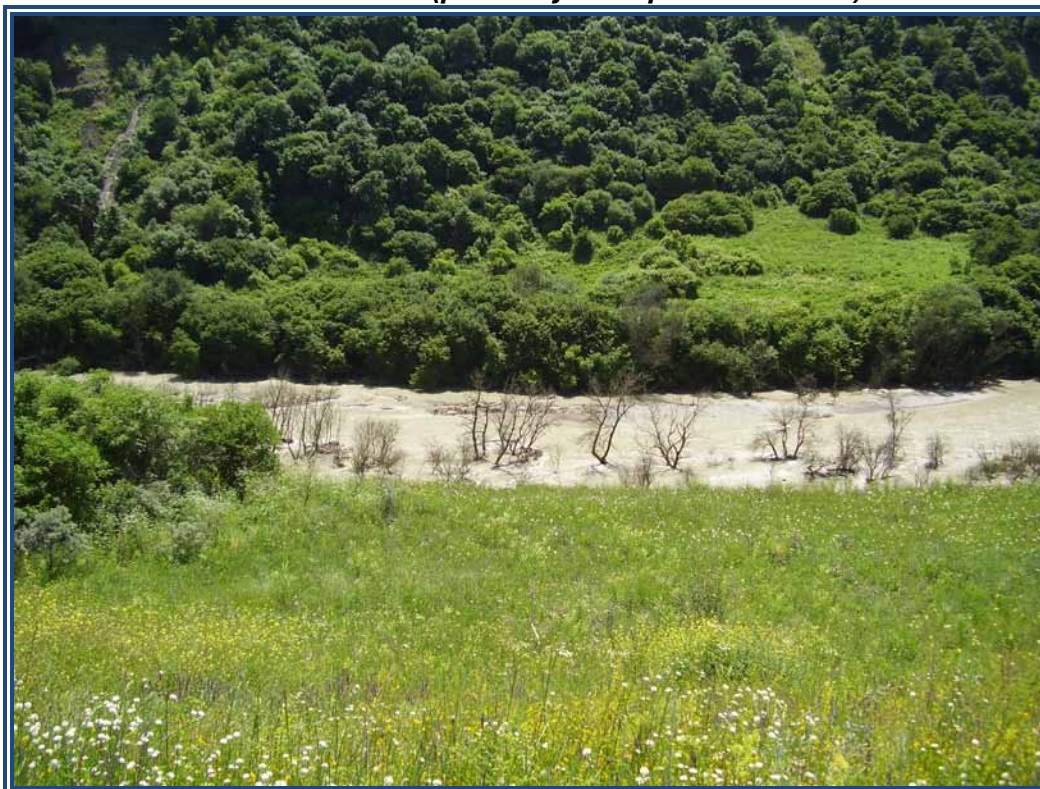
Fig. 7. 26.06.2008. Even three years after the landslide shearing the Baksan river channel upstream the former blockage dam is ponded (photo by E. Zaporozhchenko).

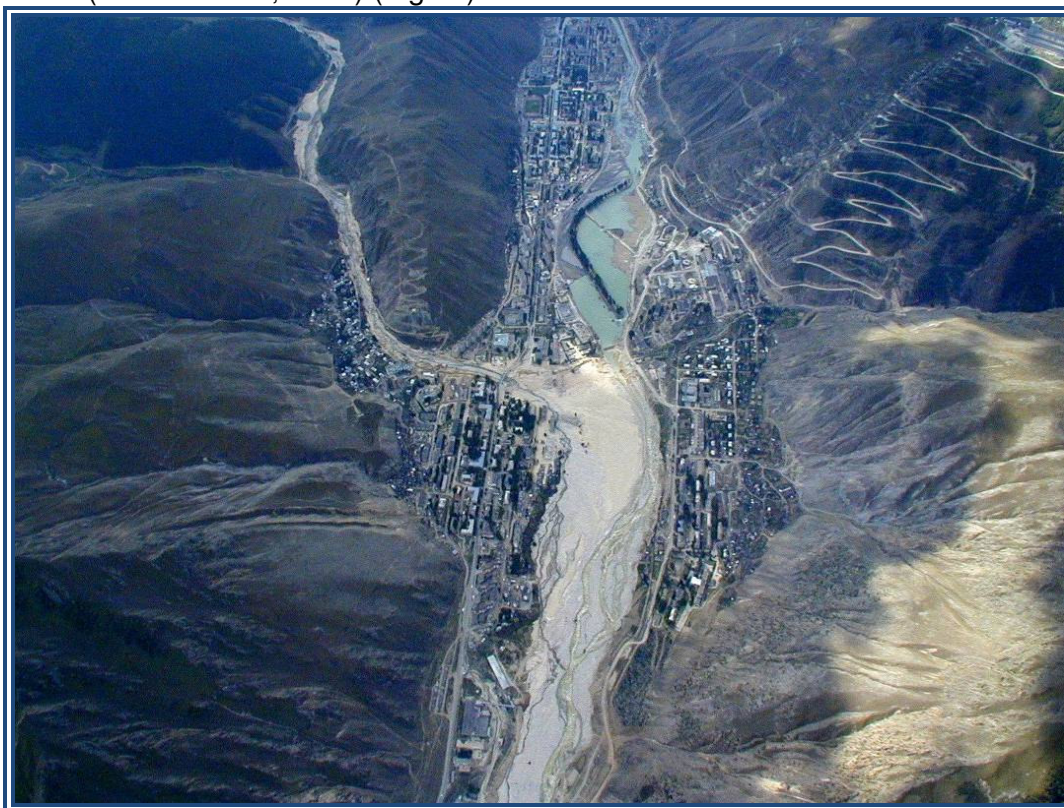
Fig. 8. Debris flow in 2000 (photo by M.Yu. Nikitin, from a helicopter)

The major part of the town is situated at the fan of the Gerkhozhan-Su river, one of the most debris flow hazardous rivers of Kabardino-Balkaria (Zapoozhchenko, 2002): destructive debris flows were registered in 1937, 1960, 1961, 1962, 1977, 1999 and 2000 (Seinova et al, 2003) (Fig. 8).

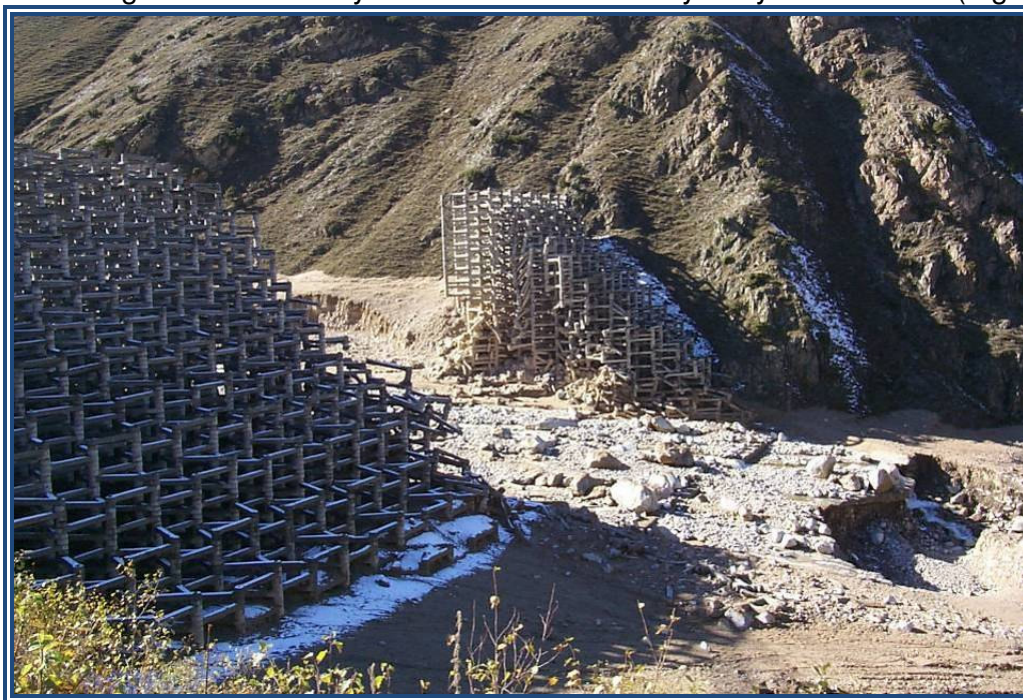
Fig. 9. The dam on the Gerkhozhan-Su river, destroyed by a debris flow in 1999 (photo by I.B. Seinova).

Construction of the structure continued 12 years and was finished in the summer of 1999. In August of the same year the dam was destroyed by a debris flow (Fig. 9)

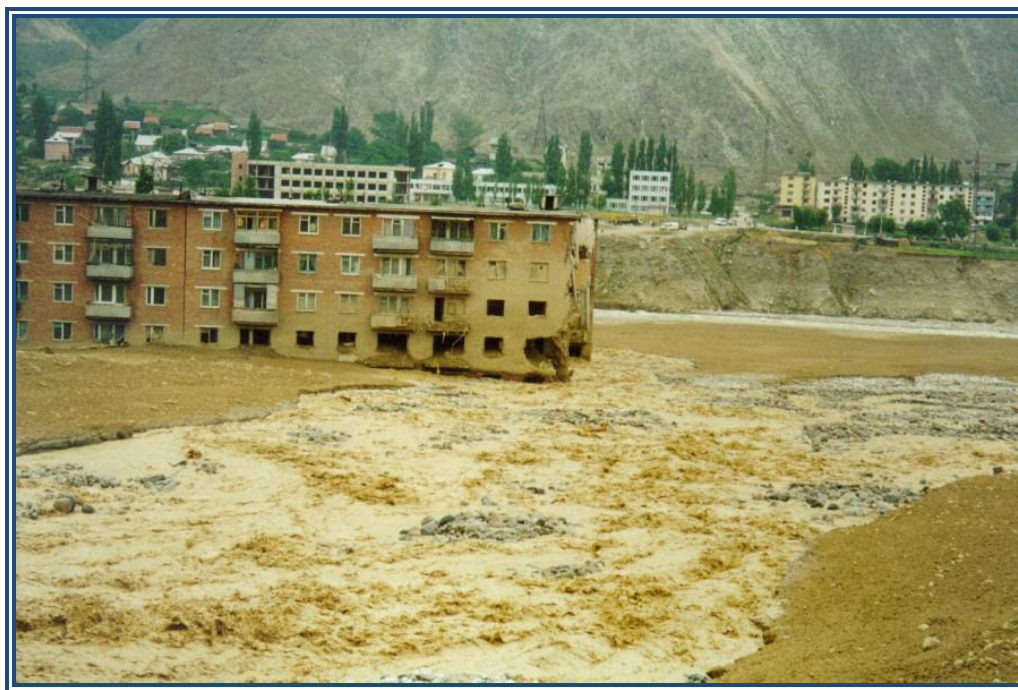
Fig. 10. Residential building in the town of Tyrnyauz, affected by a debris flow in 2000 (photo by S.S. Chernomorets)

The most powerful debris flows in the history of Tyrnyauz were those on the 18-25th July 2000. The debris flow in 2000 claimed human lives. Several blocks of flats were destroyed (Fig. 10).

The disastrous effects were caused not only by natural factors, but also by anthropogenic ones. After the debris flow of 1999 the debris flow check chute was not cleared and therefore was not able to let through the expected discharge. As the debris flow materials moved out above the mark of the top of the debris flow control chute, a 9-storey residential building, erected close to a channel on the turn of the river, was damaged. Near the conjunction of the Gerkhozhan-Su river with the Baksan river a formation of a dam lake, with an area of 0,55 square metres, took place. The central part of the town was flooded with water 3-4 m thick for a period of 2 months.

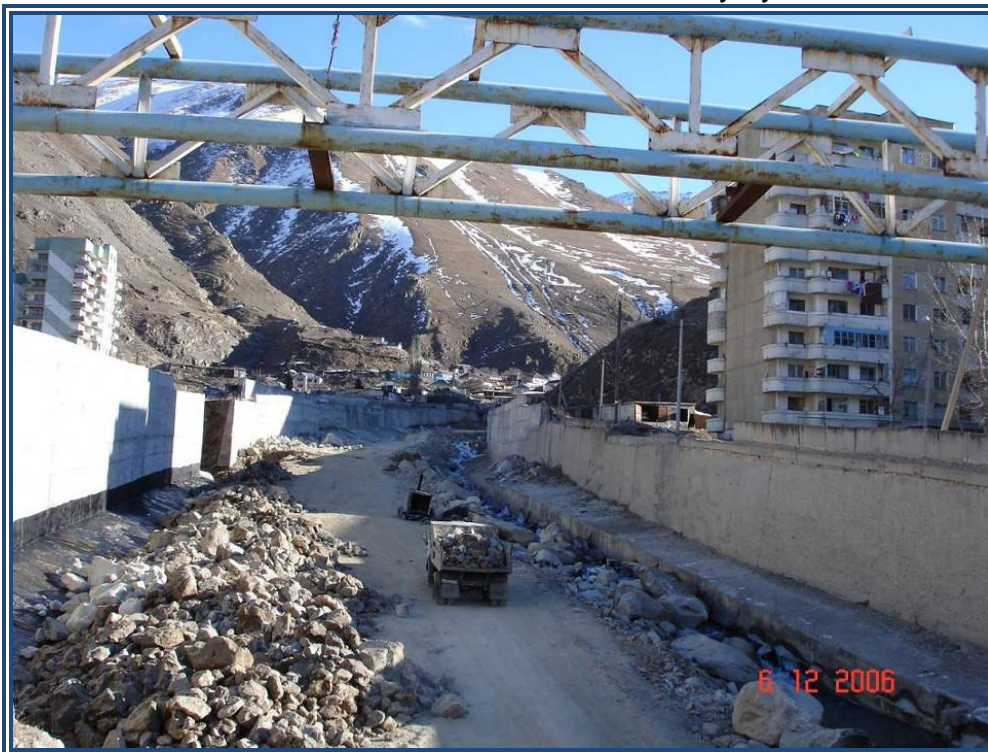
Fig. 11. Reconstruction works on the debris flow control chute in the mouth of the Gerkhozhan-Su river (photo by S.S. Chernomorets)

Reconstruction of the debris flow control chute according to the design of JSC “Sevkavgiprovdhoz” was finished in 2008. (Fig. 11).

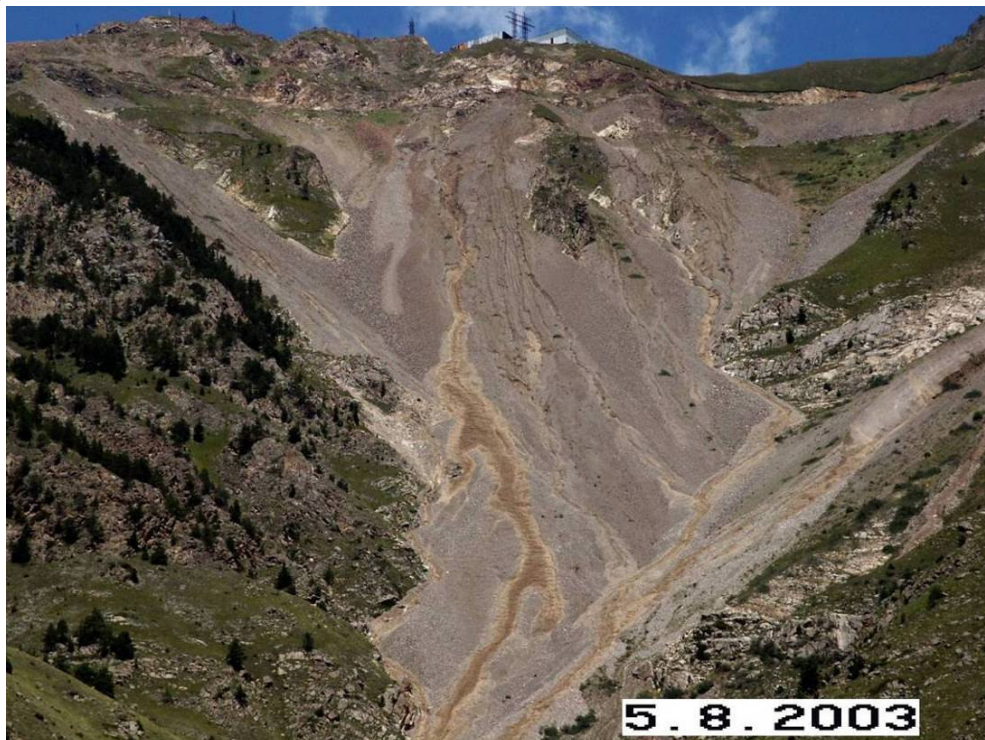
Fig. 13. The waste rocks in the basin of the Mal. Mukulan stream (photo by S.S. Chernomorets).

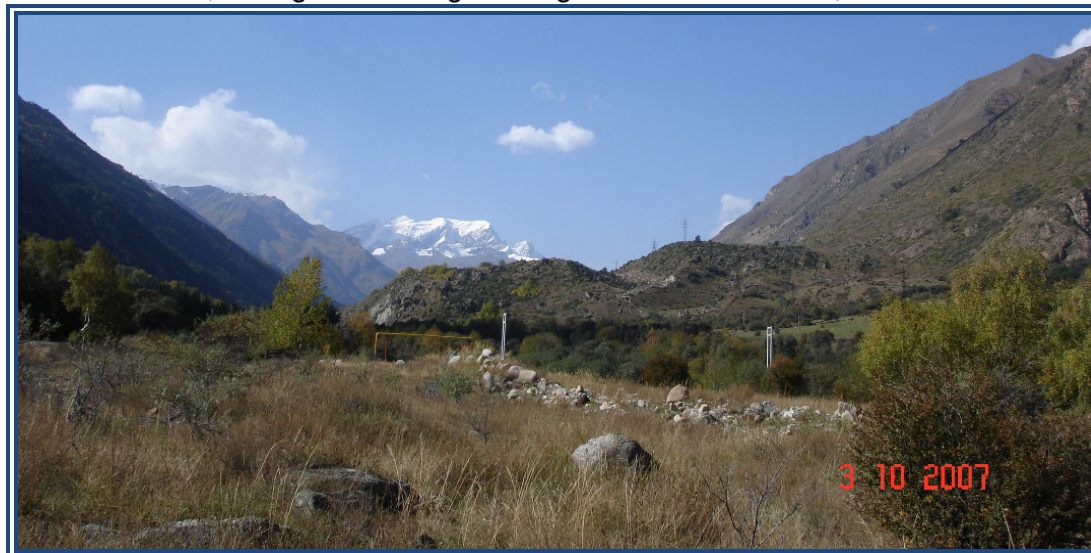
Fig. 15. The swell of Tyubele in the Baksan valley
(photo by S.S. Chernomorets)

The formation of this relief element is considered to be connected with a landslide, that travelled down from the massif on the mountains of Andyrchi and Kurymychi (the height of about 4000 m) in the end of the late Pleistocene, about 30 thousand years ago (Koronovskiy, Milanovskiy, 1960). The landslide was evidently caused by an earthquake. Blocks of gray granites overlapped the end part of the glacier

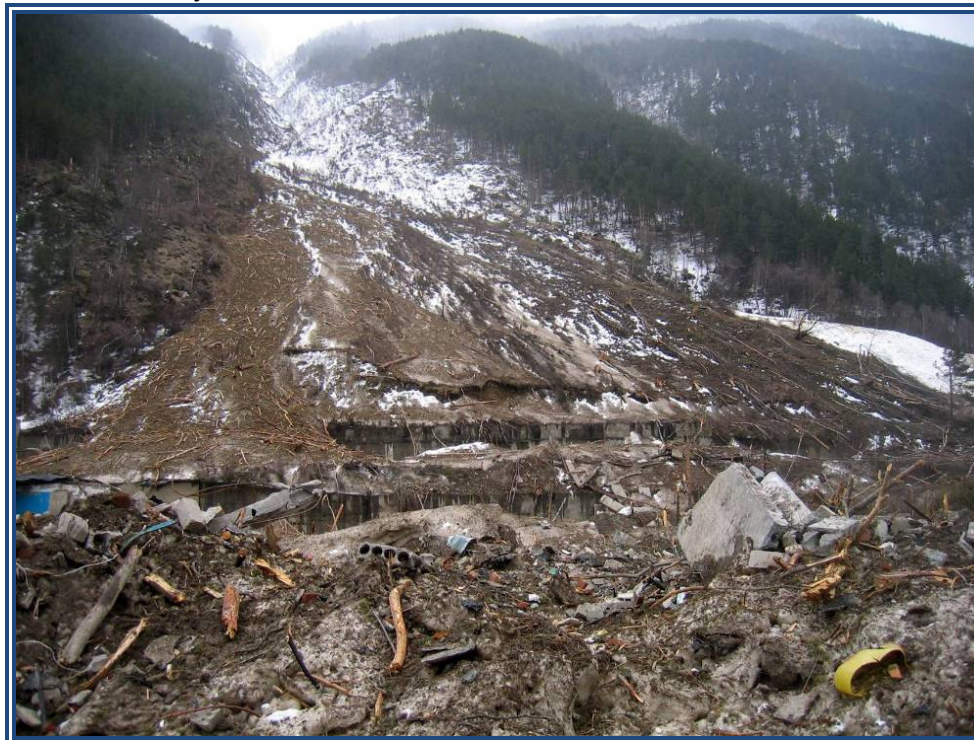
Fig. 17. The avalanche that travelled down the Andyrchi mountain on the 10th of March 2006 (photo by I.V. Krylenko).

It destroyed a two-storey building of a militarised mountain rescue unit, 3 people died. A heating plant line to the settlement of Neitrino, was destroyed and buried under 8 metres of snow; heat supply to 22 residential houses (for 610 people) was disrupted. The snow mass drifted to the other side of the gorge across the Baksan river, a bus stop and several utility structures were removed.

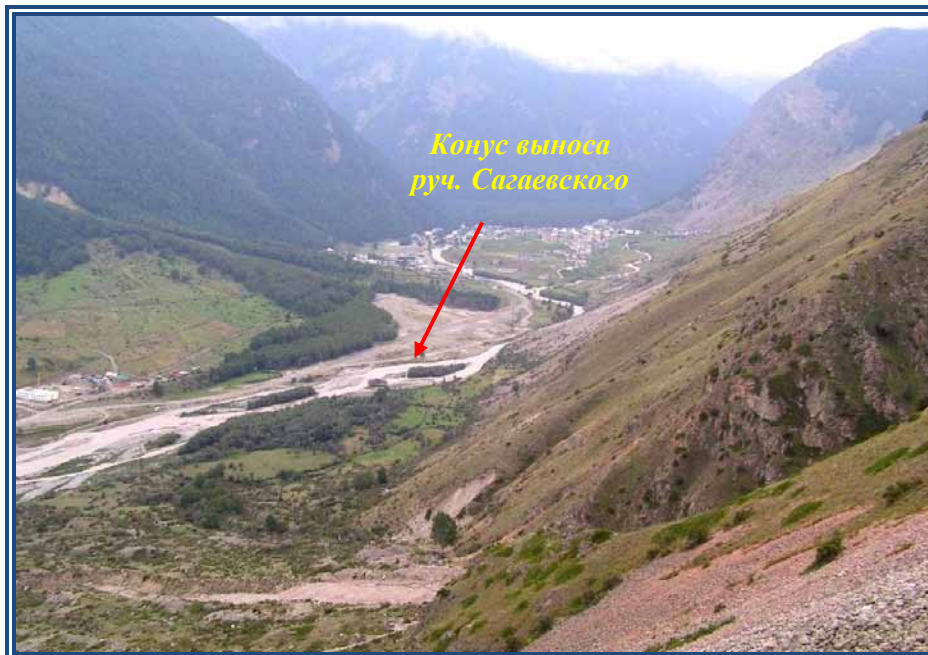
Fig. 18. The fan of the Sagayevsky stream (photo by A.M. Tarbeyeva)

In the mouth of the Sagayevsky stream there is a massive fan (Fig. 18). Its main bulk was formed at the initial stage of degradation of glaciation of the Little Ice Age. The ancient part of the fan with a thickness of deposits of up to 50 m is overlaid on the terrace of the Baksan river and cut through by a canyon with an average depth of 10 m. Lower, the present debris flow fan is formed, pushing the Baksan river to the foot of the left slope. The total area of the fan is 0,70 km², of the present fan – 0,15 km², the area of the latter constantly increases.

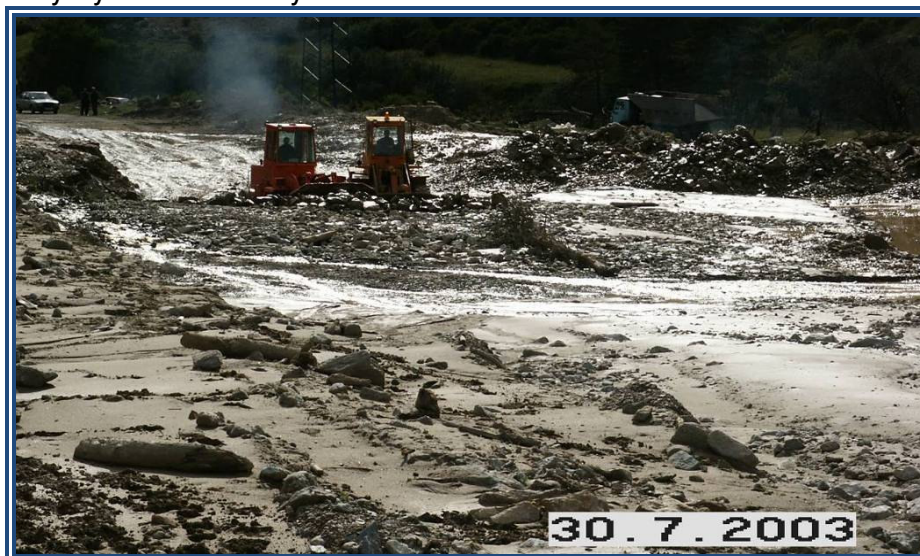
Fig. 19. The clearing of the road at the fan of the Sagayevsky stream, 2003 (photo by S.S. Chernomorets)

Avalanches and debris flows of the Sagayevsky stream travel down out to the fan, where the outskirts of the Elbrus settlement and the road are. Recurrent blockages of the road Tyrnyaуз-Terskol by debris flow masses are removed via service clearing.

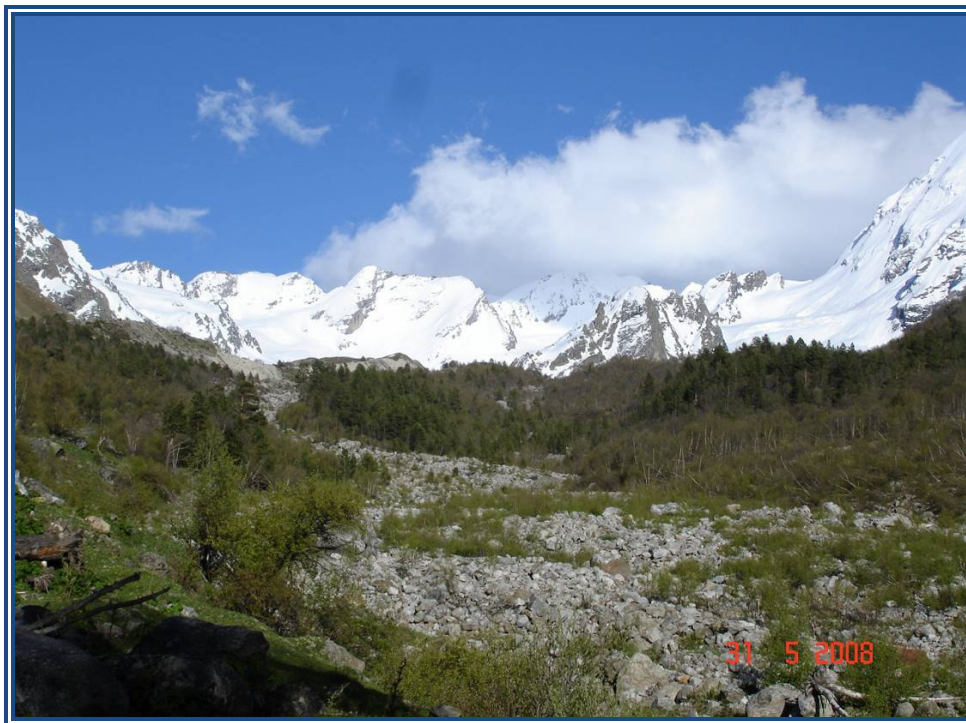
Fig. 20. The field of accumulation of debris flow deposits upstream from the alpinist base “Dzhantagan” (photo by S.S. Chernomorets)

Traces of the two debris flows of 1958 and 1959 are observed in the middle stream of the Adyl-Su, upstream from the alpinist camp “Dzhan-Tugan”, in the form of a field of accumulated large boulder debris flow deposits (Fig. 20). The volume of water, participating in the transportation of the debris flow deposits, accumulated in the middle part of the Adyl-Su valley (on the so called “Dzhantugan glade”), with a density of about 1500 kg/m^3 is about 300-6000 thousand cubic metres.

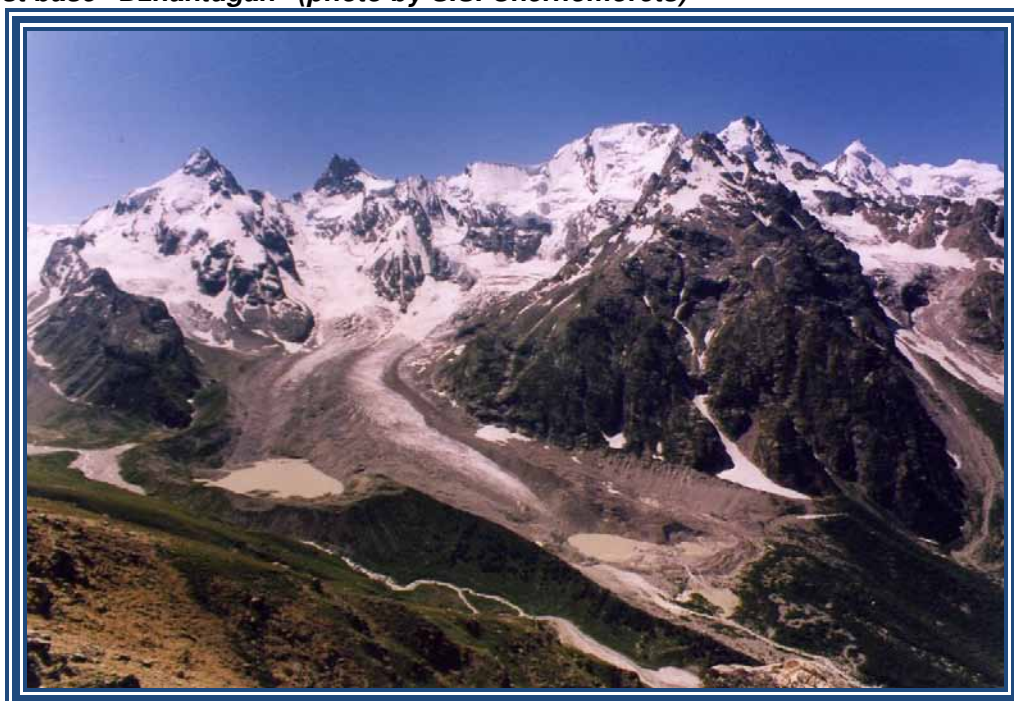
Fig. 21. The glacier Bashkara and Bashkarian lakes (photo by V.V. Krylenko)

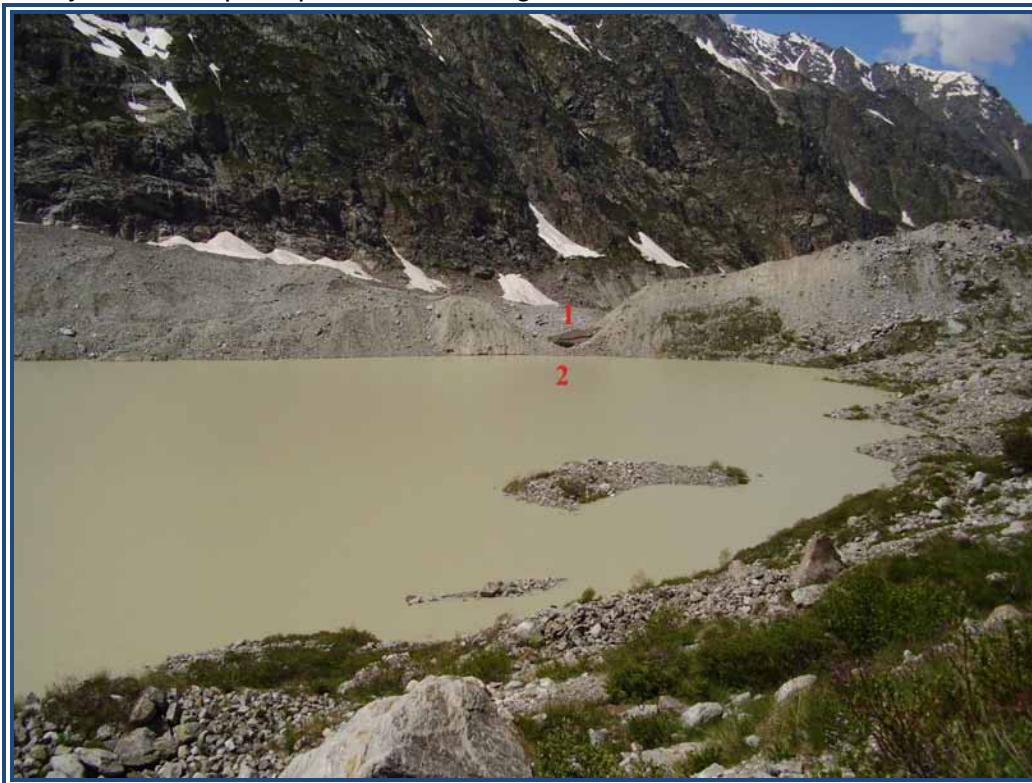
Fig. 22. 26.06.2008. The Main Bashkara lake. 1 – grotto, 2 – ice-moraine crossbar (photo by E. Zaporozhchenko).

On the 26th of June 2008 with the ice-moraine crossbar (2,2 m in height at its lowest part and 20 m in width), restraining the lake, there opened a leakage into the ice grotto, located about 35 m from the water's edge of the lake (Fig. 22, 23) and on the 17th of July 2008 an open spillover into it began.

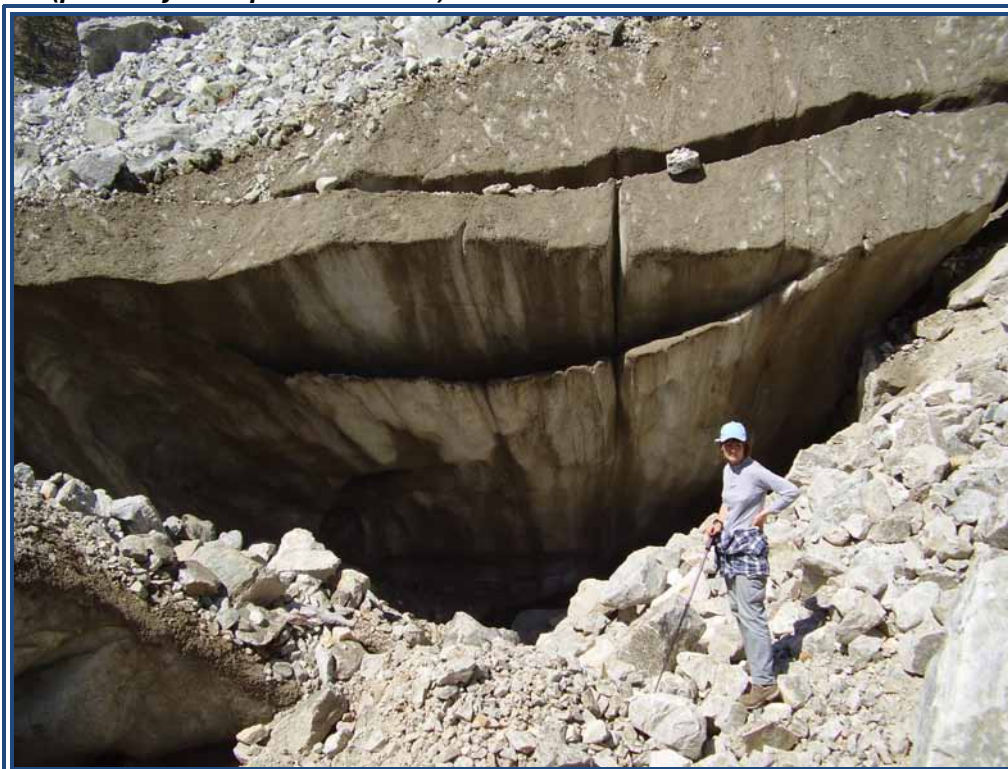
Fig. 23. 26.06.2008. The grotto about 35 m from the water's edge in the Main Bashkara lake (photo by E. Zaporozhchenko).

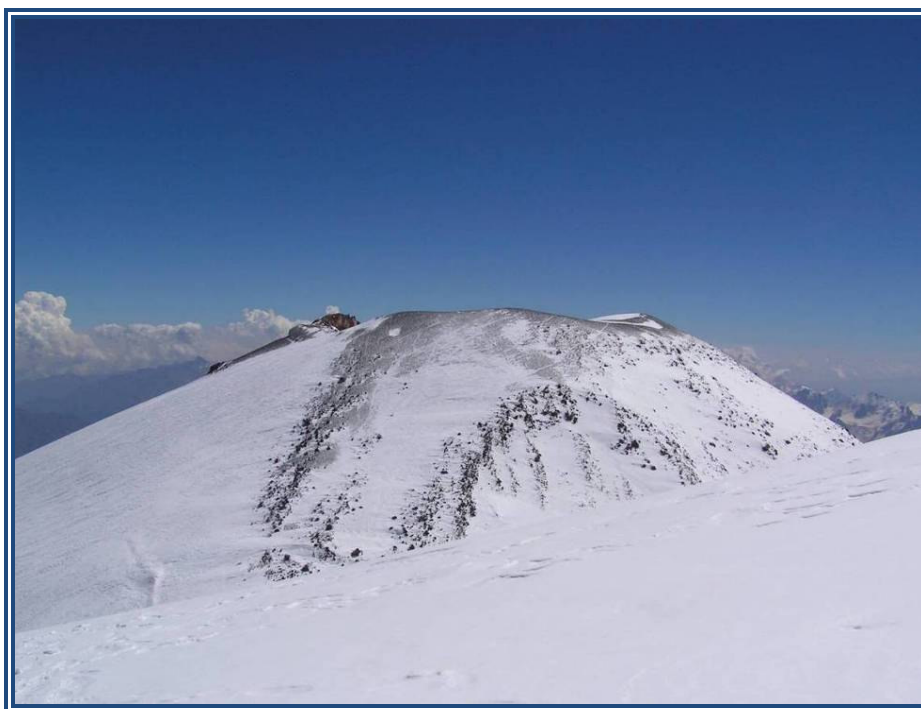
Fig. 27. The crater of the east peak of Elbrus (photo by A.M. Tarbeyeva)

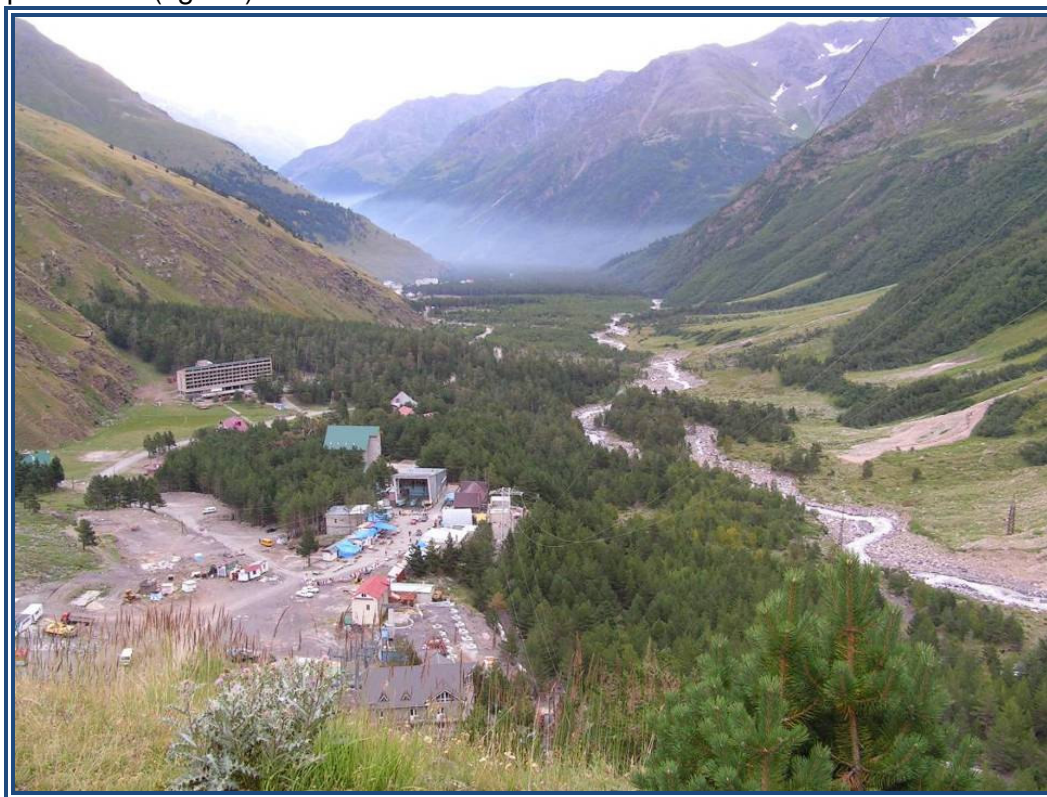
Fig. 28. The view of the Azau valley (photo by A.M. Tarbeyeve)

The Azau river, the source of the Baksan river, springs from the glaciers of Elbrus. The Azau valley is a trough, formed by a Pleistocene glacier, the morphology of which was essentially influenced by eruptions of the Elbrus volcano and further debris flow processes (fig. 28).

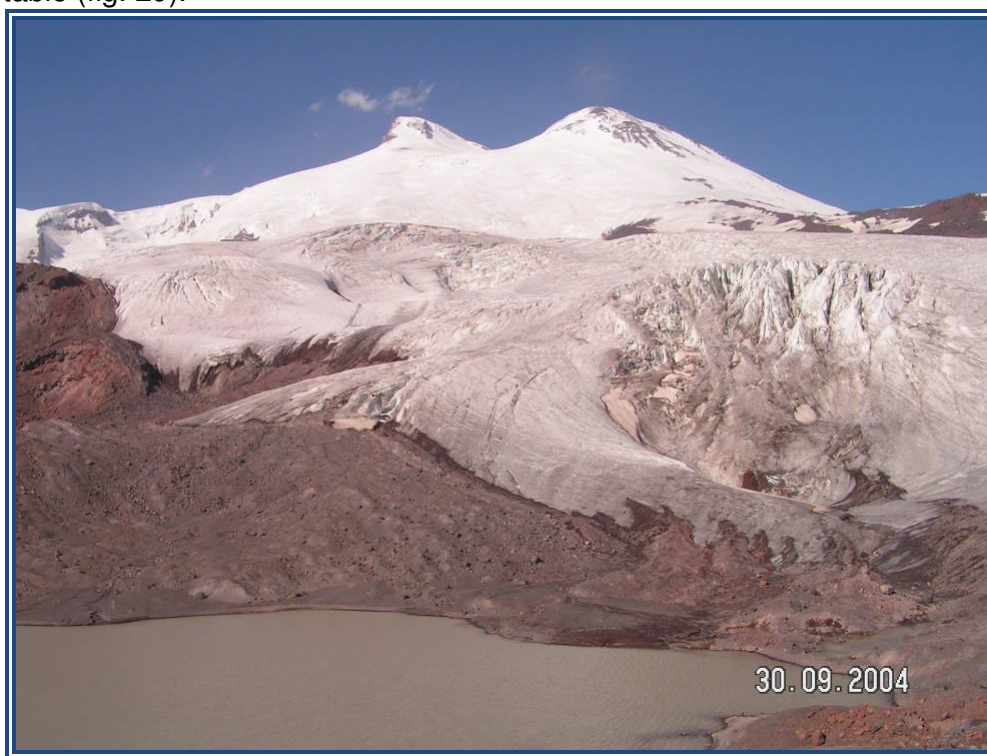
Fig. 29. The lake near the edge of the Maly Azau glacier (photo by I.N. Kargapolova)

The lake still exists at present. However in connection with the retreating of the edge of the glacier and its flattening, ice falls stopped. The dimensions of the lake are fairly stable (fig. 29).
